MINE SAFETY INVESTIGATION UNIT

INFORMATION RELEASE

Serious injury

| Event | Surface drilling incident resulting in spinal injuries |

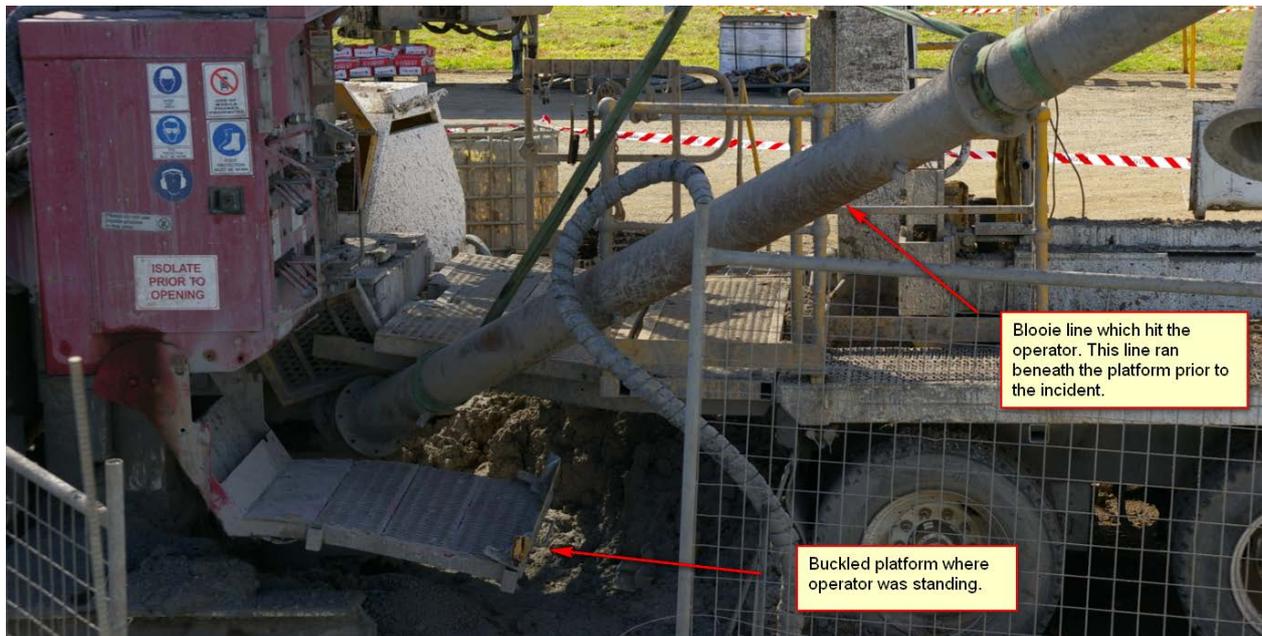
Witnesses reported a loud noise, like an explosion. The blooie line was seen to rise into the air and to cause the driller's floor and the deck floor to also rise. The drill rig operator was thrown up and fell onto the driller's console with the blooie line falling on him.

The incident scene

It seems that the primary surface casing was not installed to the correct depth and as a result the borehole wall lost integrity below the casing. This caused alluvial material and water to enter the borehole and jam the drill pipe in the hole. The driller, in his efforts to free the stuck drill pipe, pressurised the hole behind the blockage and began back reaming.

As the blockage broke free a catastrophic release of water and cuttings has ejected from the borehole annulus creating the explosion observed by the drilling supervisor.

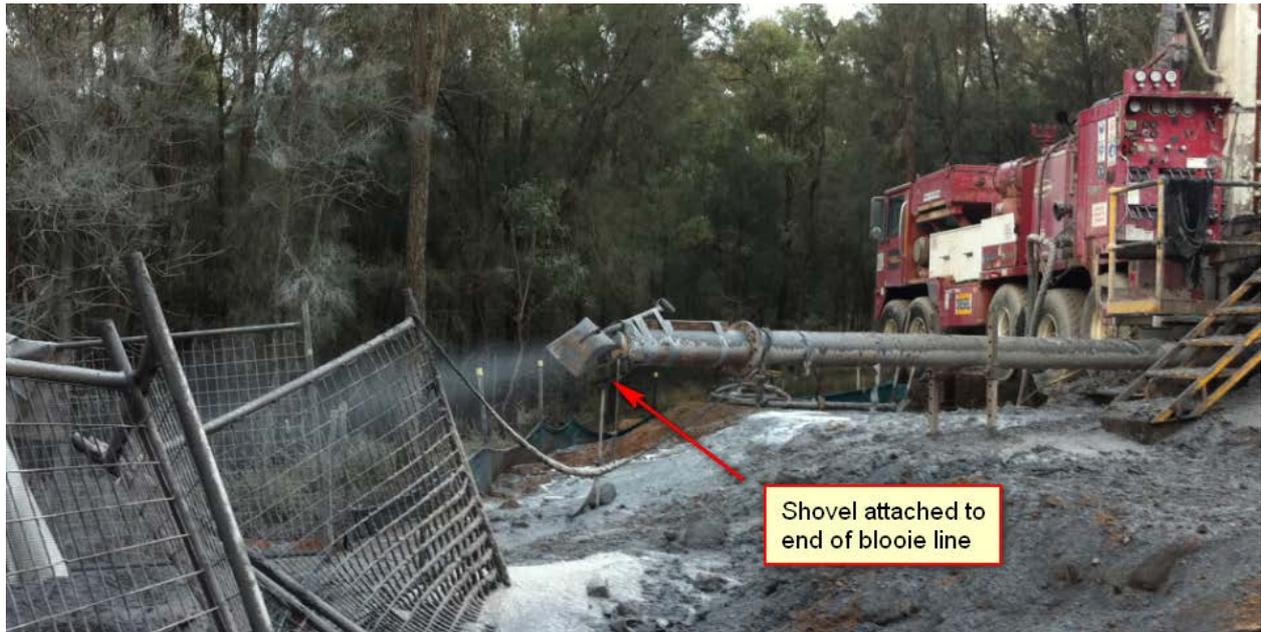
As an interim measure, a shovel was tied to the end of the blooie line to deflect material downwards.

Blooie line at borehole 3 passing under the driller's platform

Before starting borehole 4, the end of the blooie line was modified by fitting a 90° elbow on the end of it to try to direct the drilling fluids into the sump below.

A driller's offsider reported that the air discharge line was seen to move when in use, which led to attempts to anchor the pipe with two star pickets and fencing wire.

The modification to the blooie line configuration appears to have been ad hoc, and undertaken without proper design consideration or risk assessment.

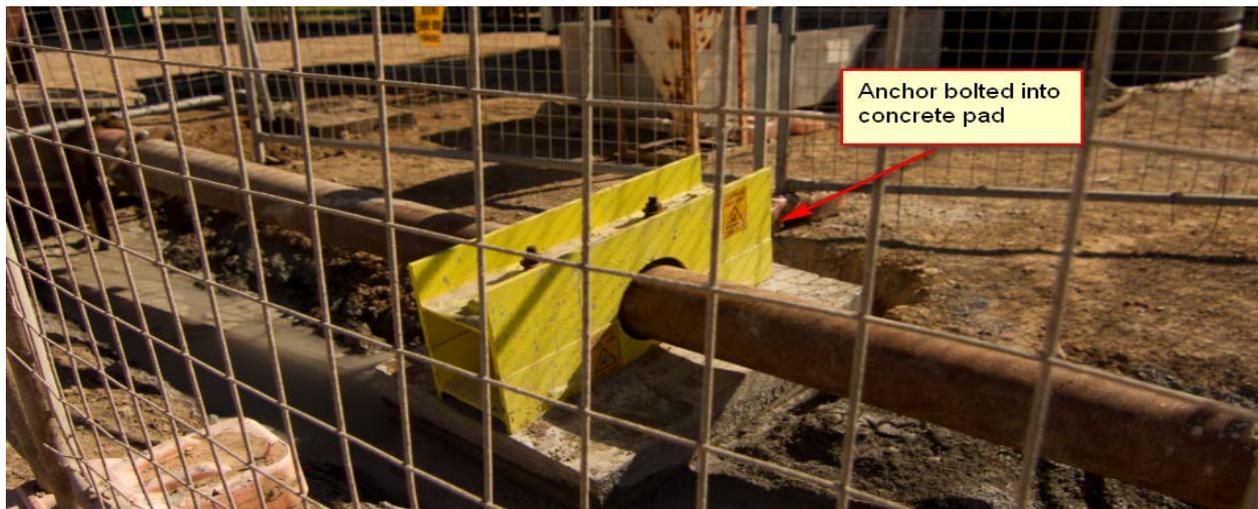
A blooie line anchoring method used at Ashton Coal following the incident

- Provide geotechnical assistance to the drilling crew to install surface casing in competent bedrock.
- Design surface casing to effectively withstand the maximum possible pressure available from the drilling operations.
- Design an anchoring system for the air discharge line to withstand maximum possible pressure available from the drilling operations.
- Design the drill pad and sump so that a 90° elbow is not required.
- Create a drill program in consultation with the drillers who are to perform the work.
- Identify change in the system of work and effectively manage the risk created from that change.
