# SAFETY BULLETIN

DATE: NOVEMBER 2019

## Drive shaft failures causing fires

This safety bulletin provides safety advice for the NSW mining industry.

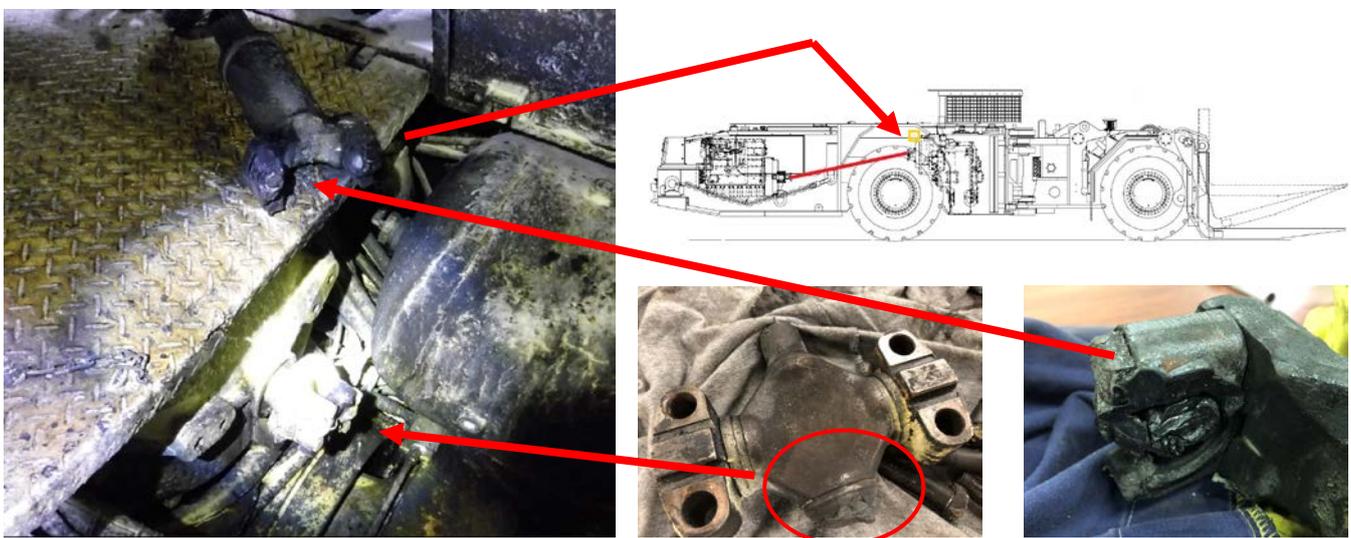
*Figure 1 Failed universal joint on underground coal, heavy haulage load haul dump (LHD) machine*

A shield hauler was driving in an underground coal mine, when a bearing failed on the universal joint connecting the drive shaft from the engine to the torque converter, at the torque converter end. The drive shaft was not restrained by safety loops. Before the engine could be shut down, the drive shaft spinning at engine speed contacted components, hydraulic and pneumatic lines, which resulted in a spray of hydraulic fluid and compressed air that ignited. The operator manually activated the fire suppression system that extinguished the main fire. The operator also had to use a hand-held fire extinguisher to snuff a fire in the sound suppression material, which was on the underside of a transmission area access cover knocked open by the drive shaft.

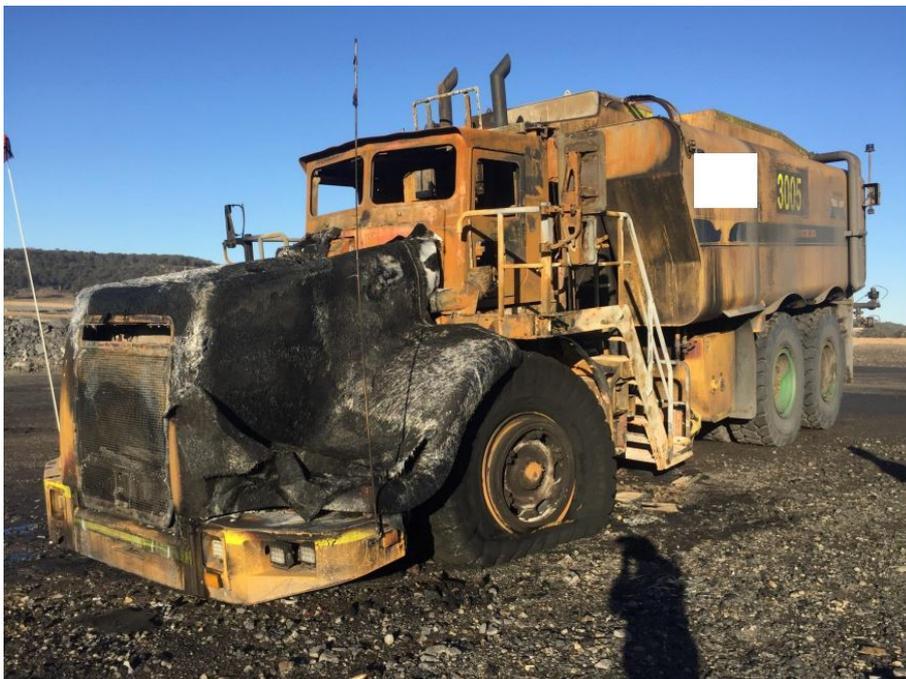
*Figure 2 Watercart extensively damaged following drive shaft failure*

An articulated water cart was travelling down a haul road at an open cut coal mine when the front main drive shaft universal joint failed. As it failed, the loose rotating shaft destroyed a guard and damaged the main hydraulic pump and hoses. This sprayed hydraulic oil onto the engine, which ignited on hot components. The operator stopped the truck and activated the fire suppression system. The operator safely exited the vehicle before the fire reignited, extensively damaging the truck.

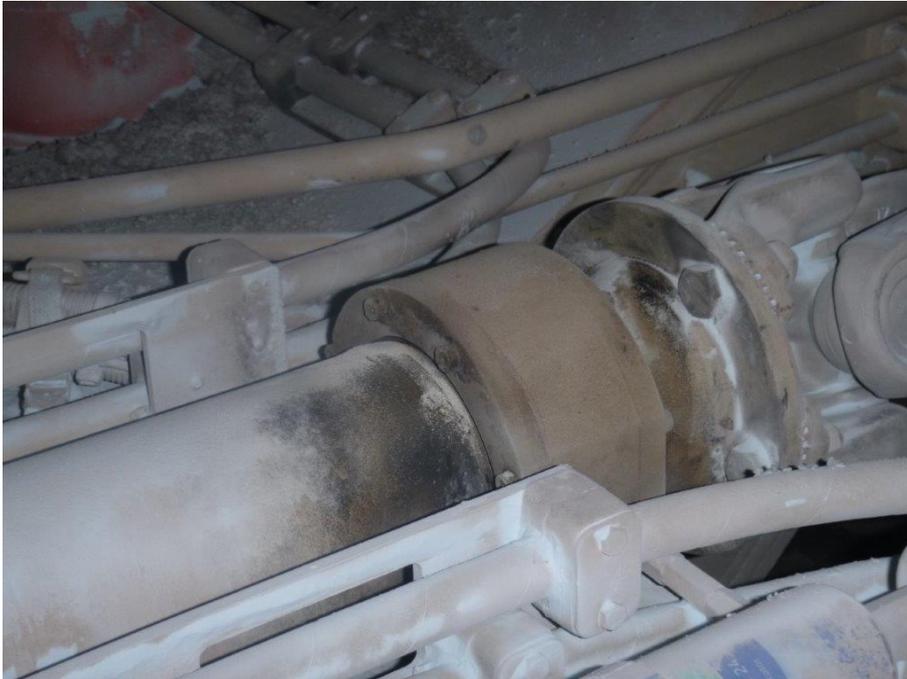
*Figure 3 Heat damage to an underground haul truck*

At an underground metalliferous mine, a loader operator saw a glow from under a haul truck. The loader operator radioed a truck operator who stopped and extinguished a small bearing fire on the tail shaft. Following the incident, the original equipment manufacturer (OEM) issued a safety bulletin.
