# SAFETY ALERT

## Rock falls from elevated conveyor onto worker's head

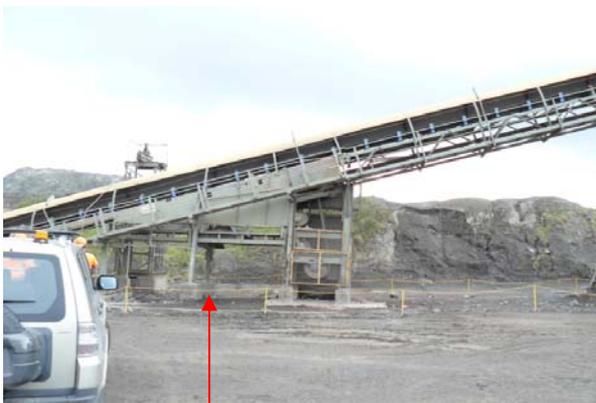
A considerable quantity of rock was observed to be lying on the walkway next to the conveyor, on steel sections of the conveyor structure, on electrical cables and on the ground on both sides of the conveyor for much of the length of the conveyor.

A rock deflection guard had been installed to protect road traffic but this covered only a small area under the conveyor and the deflector was not fitted with sides to prevent rocks deflecting sideways at right angles to the conveyor.

The injured worker was standing in this area when struck by the rock.

1. Assess the potential for material to fall into any accessible area and cause injury, giving due consideration to the height of the fall, maximum speed and weight of the falling material.
2. Where there is any potential for material to fall from a height which may result in injury, take effective means to prevent such injuries.
3. Any area where conveyed materials can accidentally fall or be projected onto persons should be classified as a danger zone and appropriate guards and warning signs must be provided.
4. Consider installing belt tracking limits to prevent belt edge damage and reduce potential for material to spill from the conveyor.
5. Consider maximising the belt troughing angles for elevating conveyors to reduce potential for material to spill.
6. Where practical, take effective steps to prevent localised overload of conveyors which may result in spillage.

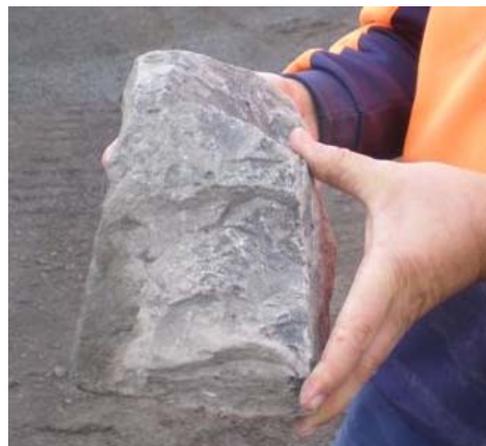
A 10 kilogram rock fell from an overhead elevating conveyor and hit the safety hat of a nearby worker resulting in head injuries, a broken tooth and injury to the area between the worker's head and shoulder.

The rock which struck the worker.
