SAFETY ALERT

Fire ignites after worker drills into a sealed void

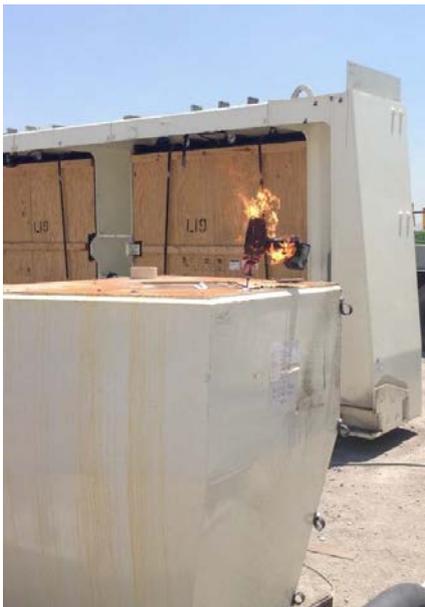
A tradesman drilled into an enclosed excavator counterweight using a battery drill. Gas was released as the worker drilled through the steel plate.

Photo 1: Enclosed compartment with the battery drill

Repair instructions were requested from the manufacturer. Before the repair instructions were received, a hole was drilled into the top surface of the enclosed section of the counter weight to relieve the pressure. This caused an uncontrolled release of hydrogen gas stored under pressure in the counterweight, which ignited as it passed the hot drill bit on the electric drill.

- The counterweight is comprised of a number of compartments filled with steel and concrete to ~95% to 98% of the internal volume and sealed by welding a plate over the access hole.
- A chemical reaction between the steel and the moisture in the concrete generates hydrogen. As the hydrogen cannot escape, pressure builds, deforming the steel work of the compartment.
- Test samples of the entrapped gas varied in hydrogen content, one sample contained 5.4% hydrogen. The lower and upper explosive limits of hydrogen in air are 4% and 74% respectively.

- The counterweight was quarantined and fitted with a danger sign.
- The OEM supplied a procedure for drilling into the voids.
- Risk assessments were carried out and a safe work procedure developed for drilling into the sealed compartments where there was potential for a fuel (hydrogen) enriched atmosphere.

- External advice was sourced from people with competence in carrying out hot work on confined spaces with a flammable gas inside the compartment.
- An air operated and remote controlled drill that could drill and retract automatically with a magnetic base, was used.

- Pre-drilling trials were carried out in which temperature measurements were taken to prove the temperature reached would not ignite the hydrogen gas.

- Safe zones were established.
- A camera monitored the drilling process.
- Firefighting equipment was prepared.
- Inert gas flushing of cavities was carried out when the holes were drilled.

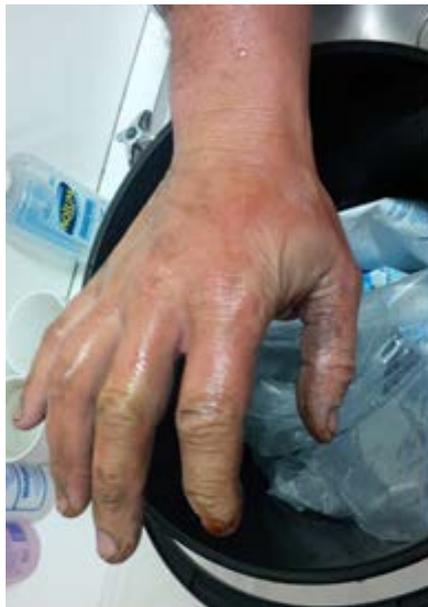
The gas ignited and the tradesman suffered second degree burns to his right hand. He was not wearing gloves.

Photo 2: Burn injury to right hand

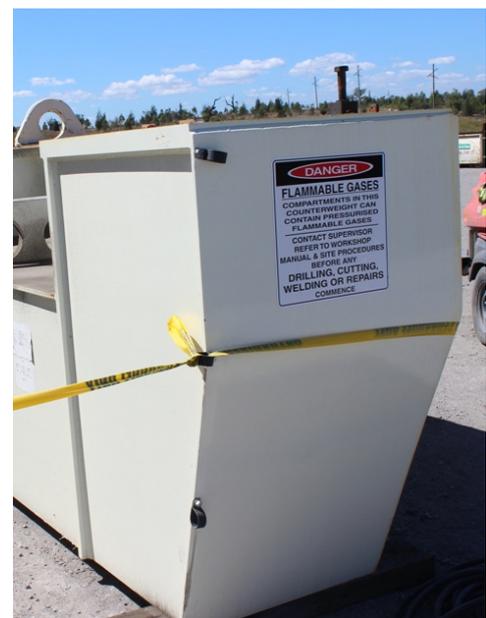
Photo 3: Danger flammable gases sign installed after incident
