SAFETY ALERT

In-service failure of safety critical steering component

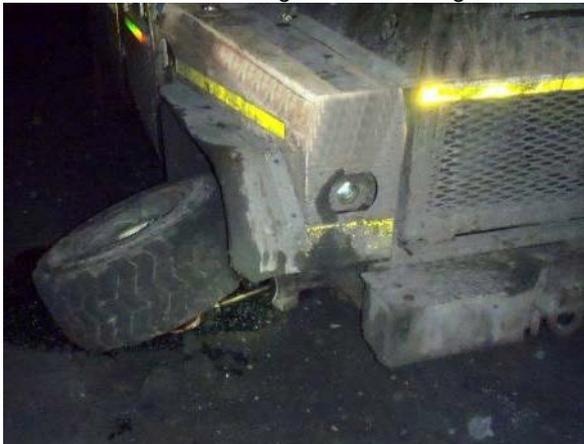
Photo 1: Failure to front right-hand steering knuckle

An investigation identified both the left and right stub axle steering knuckle assemblies failed. Both failures had been previously repaired. One repair was a re-weld of the stub axle. In the other repair, the stub axle was machined undersize and a repair sleeve was fitted. Other vehicles at the mine with similar axle assemblies were inspected for failings with six out of ten identified as needing replacement.

The vehicle manufacturer recommends that stub axle assemblies be replaced, not repaired.

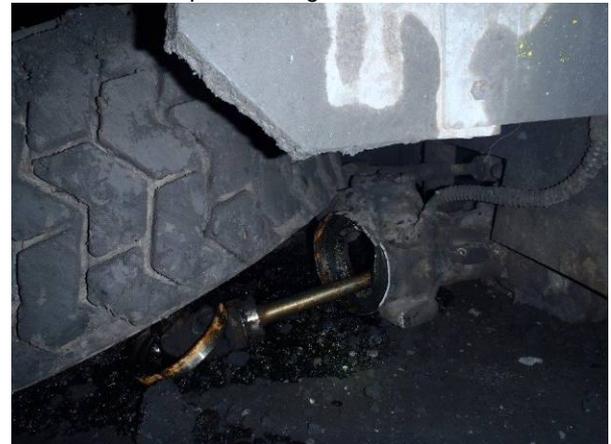
Photo 2: Close-up view of right-hand failure

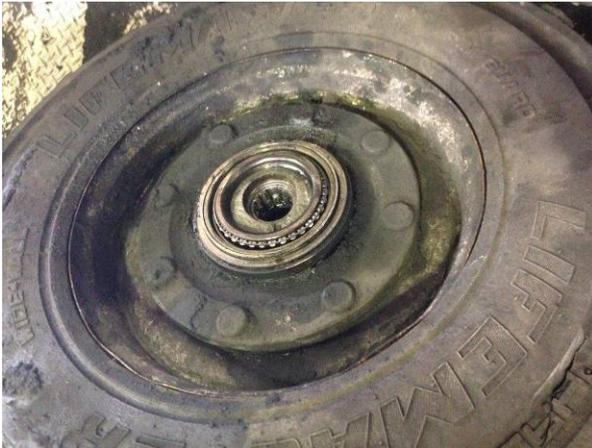
Photo 3: Failure to stub axle left-hand side

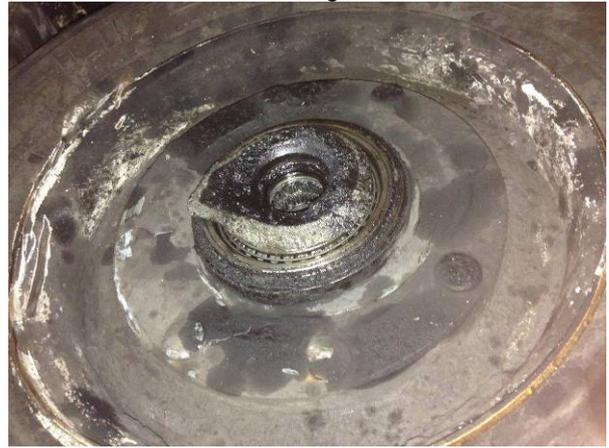
Photo 4: Failed stub axle right-hand side

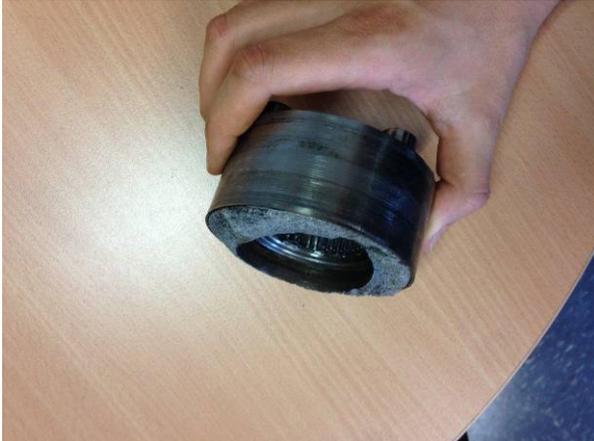
Photo 5: Stub axle re-sleeved

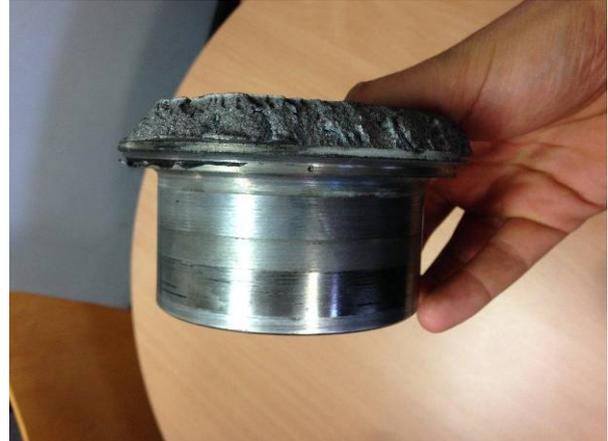
Photo 6: Failed stub axle
