# SAFETY ALERT

## DRILLER'S OFF-SIDER INJURED WHILE OPERATING AN EXPLORATION DRILL RIG

Report No: SA 05-03  
Comet ID 317519514001  
Date: 28/03/05  
Prepared by: Mark Stephens  
Phone (02) 63926350

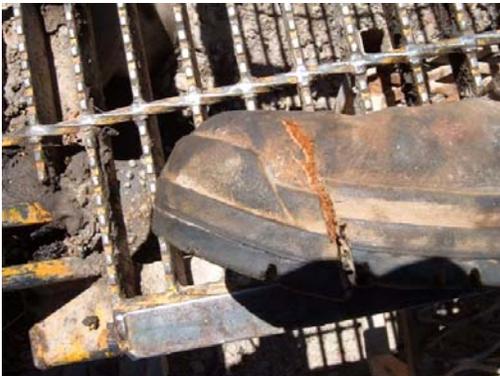
The driller released the foot clamp around the drill rods to raise them towards the top of the mast. The off-sider braced himself by placing his foot on the rod clamp guard to begin the removal of rods. When the rod clamp was closed the off-sider's right foot was dragged down by the closing action of the rod clamps. This resulted in a tear behind the steel cap of the boot which nearly removed his big toenail.

Damaged Boot

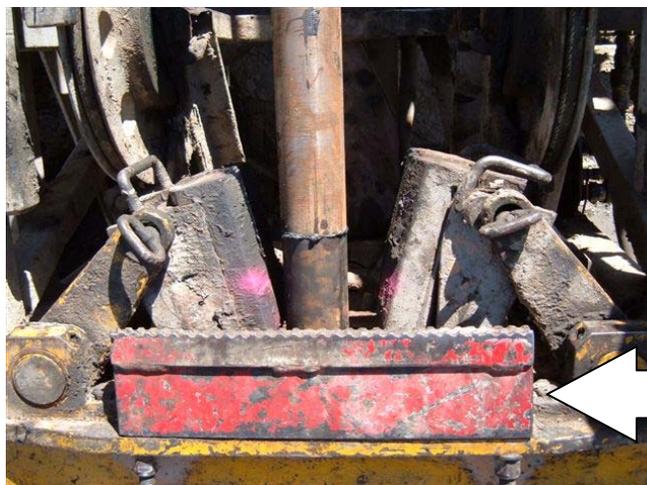
- Drill rods were being "pulled" using a rod spinner.
- The driller's off-sider braced himself to remove the next rod by placing his right foot on top of the rod clamp guard.
- Without seeing where the off-sider's foot was located, the driller closed the rod clamp as normal practice.
- The rod clamp came down and quickly dragged the boot down with the clamp into the pinch point and caused the injuries.
- The exploration drill rig was a Universal UDR 1000, which are extensively used throughout Australia for exploration.
- The rod clamp guard that was on the rig was not a standard UDR part and did not protect the off-sider's foot from the pinch point of the clamp.
- Universal UDR 1000, 1200 and 650 drill rigs all have the same clamp arrangement.

Picture showing rod clamps in open position with existing but apparently inadequate guard (worn red colour). The rod spinner is removed for clarity.

Inadequate guard

All exploration drill rig owners and operators should review the systems used for guarding of rod clamps on their drill rigs. If deemed necessary, rig owners should replace the guards to ensure pinch point protection is adequate.

Mines should inform the workforce of the hazards associated with drill rigs and assess the adequacy of guarding, especially on Universal UDR 1000, 1200 & 650 drill rigs

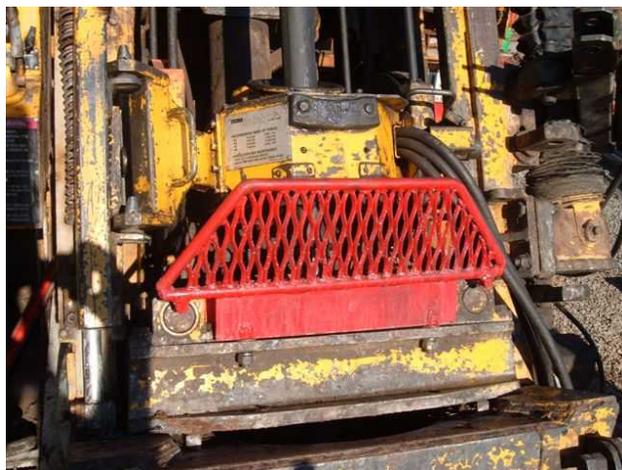
Picture shows a new guard covering pinch points
