SAFETY ALERT

ELECTRIC SHOCK FROM 11 KV BUS TIE

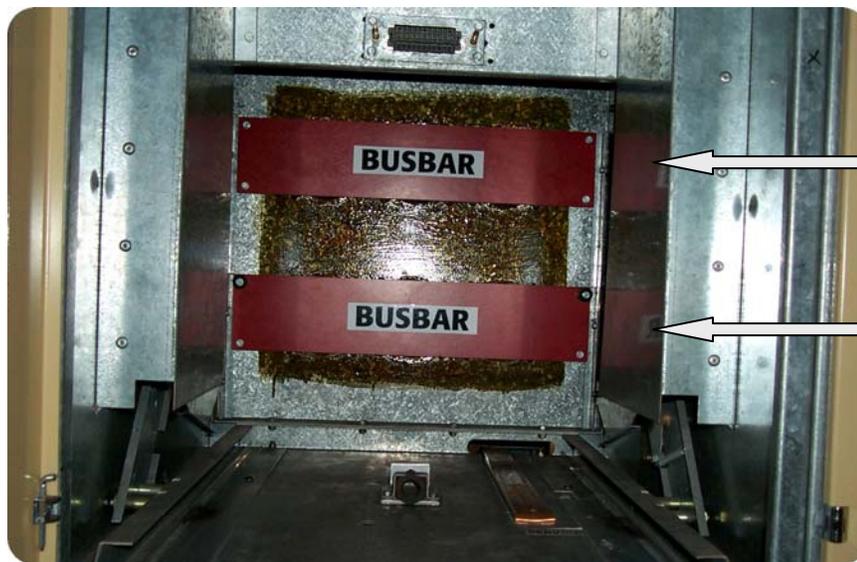
Photograph 2. View into the bus tie breaker cubicle

Flaps over 11 kV bushings.

These flaps are normally lifted clear automatically by a mechanical action when the circuit breaker is pushed into the cubicle.

On this occasion, the electrician lifted the flap manually to access the bushings to wipe them down.

The bus tie breaker has been removed. A bus tie breaker is a means of connecting the bus bars in one half of a distribution board, to the bus bars in the other half. Because only half the board had been isolated, one side or the other of the bus tie was certain to be live. The incident occurred when the electrician lifted the flap on the upper set of bushings, encountering the live 11 kV parts.

Before high voltage work is undertaken the following actions must be completed:

1. A properly conducted formal risk assessment must be carried out to examine any possibility of people coming into contact with energised conductors.
2. Detailed planning of the work must be carried out by a competent person.

3. A detailed documented work plan must be prepared with provisions for verification of each step.
4. Every step must be clearly and effectively communicated to all persons involved in the supervision and work.
5. Mines should ensure that they have an effective contractor management system to oversee planning and performance of contract tasks.
