WEEKLY INCIDENT SUMMARY

Week ending Friday 24 July 2020

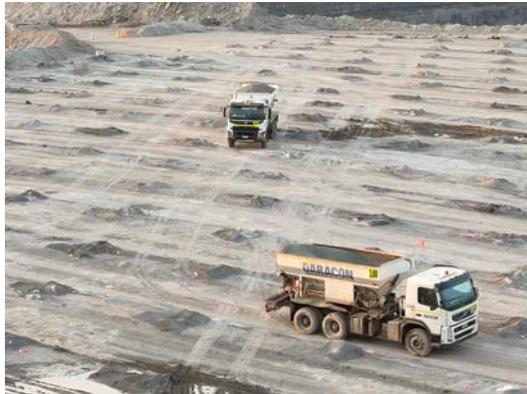
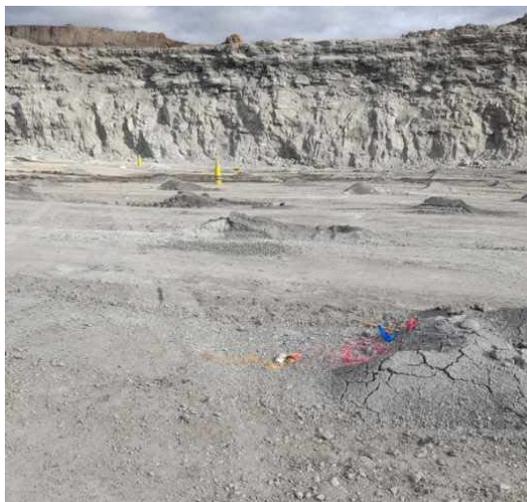
INCIDENT TYPE	SUMMARY	COMMENTS TO INDUSTRY
Dangerous incident IncNot0037797 Open cut coal

<p>A stemming truck ran over a detonator and booster during the loading of shot holes. The shotfirer in charge removed one level of IE/HE from the holes and placed them adjacent to the holes on the next path.</p> <p>After travelling the same path on five occasions that morning, the stemming truck operator has turned down the adjacent path.</p> <p>The operator did not see the detonator and booster on the ground and drove over it. No ignition of the explosives occurred.</p>	<p>The traffic management plan for the shot floor should clearly identify travel routes so that trucks do not inadvertently drive along the incorrect path.</p> <p>Drivers should know the travel routes before entering the shot floor. To aid the drivers, demarcation of usable tracks should be clearly identified by using visible cues such as cones or signage.</p> <p>Mines should ensure effective supervision and auditing of compliance with documented traffic management plans.</p>

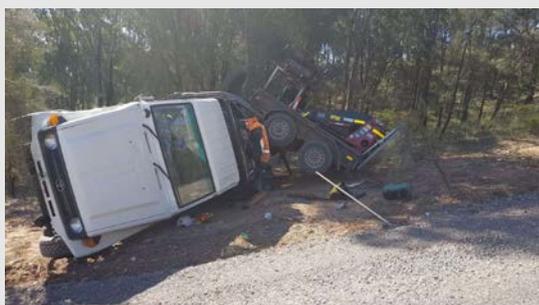
Dangerous
incident
IncNot0037817
Open cut coal

A light vehicle towing a trailer loaded with a dingo, ran out of power while pulling the trailer up a steep section of road. The trailer and vehicle rolled backwards down the road and both overturned one and a half times.

The driver was uninjured.

It appears the vehicle hubs were not engaged, and the operator was towing in 2-wheel high range.

Mines should ensure that vehicles and trailers are fit-for-purpose when being used to transport a load. The suitability of the towing vehicle to handle the trailer mass and the trailer load should be assessed.

Mines should check that their 'introduction to site' process is being properly applied and ensure that vehicle operators are competent to use the vehicle for towing purposes.
