MINE SAFETY INVESTIGATION UNIT

INFORMATION RELEASE

Fatality

Date	7 March 2013
Event	Body found at bottom of a blind shaft
Location	Lightning Ridge, NSW

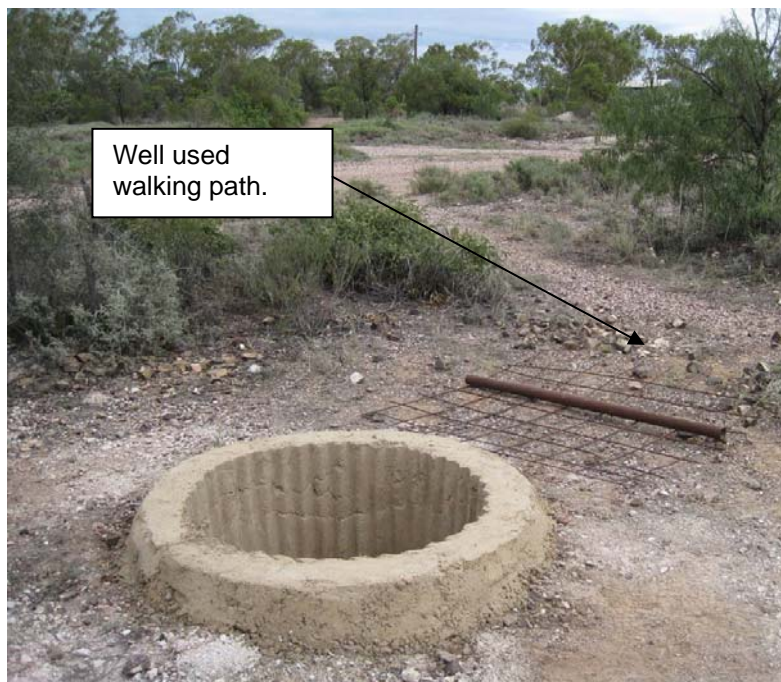
The shaft was 13.6 metres deep and was a blind shaft, i.e. no workings had been developed from it. It had been drilled about six months prior to the incident. The collar of the shaft was raised approximately 0.1m above the ground and lined the top of the hole. It was 1.05m in diameter at the top.

The shaft had a cover constructed of a piece of steel reinforcing mesh and steel pipe.

The shaft and cover as described by a witness
