SAFETY ALERT

Catastrophic failure of auxiliary fan

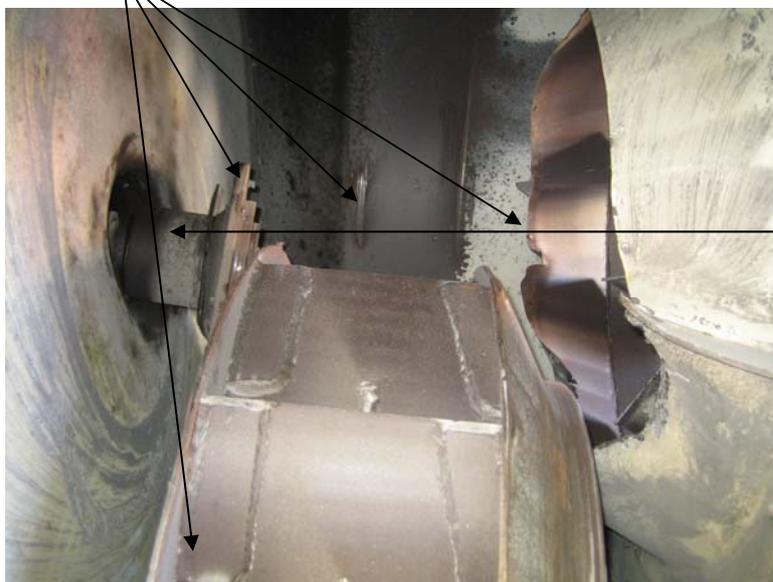
Figure 1

Fan housing impeller damage

Bent motor shaft

The fan failure has been subject to an extensive engineering investigation. It has been concluded that the incident was caused by excessive vibration, resulting in the failure of the drive end bearing carrier. This resulted in the motor shaft contacting the flameproof housing with the resultant heat and rotary energy causing the other damage. The manufacturers have informed their clients of this failure mode. Other issues were identified during the investigation. Salient points were:

1. A design risk assessment for the life cycle of the fan that incorporates a fan and motor failure mode effects analysis.
2. Incorporate design features to prevent a reoccurrence of this type of event.

3. Ensure compliance with MDG 3.
4. Ensure that fan monitoring and interlocks are designed and operated to an appropriate safety integrity level.
5. Implement a suitable vibration monitoring program utilising:

- a. Correct type of sensors
 - b. Correctly located sensors
 - c. Calibrated sensors
 - d. Correct alarm and trip settings
 - e. Review by vibration analysts.

6. Implement a suitable auxiliary fan maintenance program that:
 - a. Ensures correct greasing of bearings
 - b. Regular cleaning of fan impellers
 - c. Proof testing of alarms and trip systems.

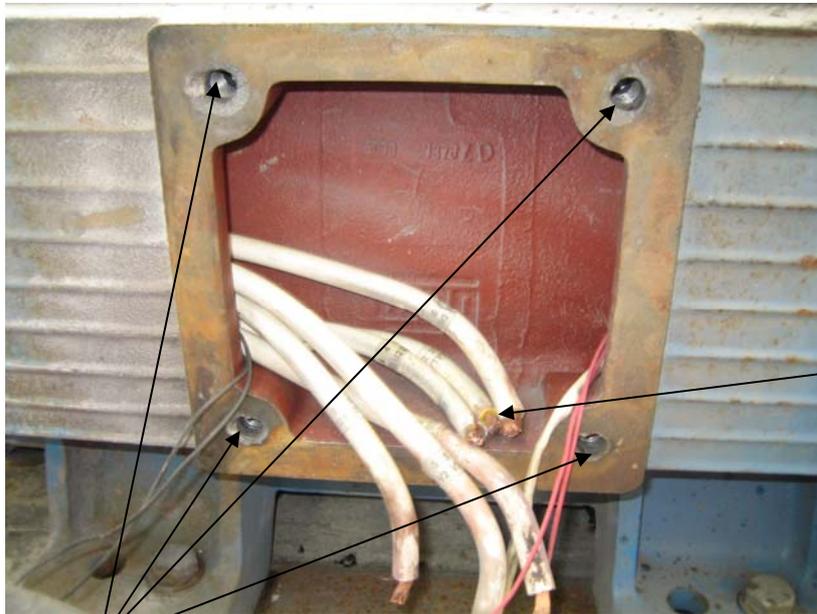
Figure 2

*Arcing to motor
leads as
connection box
torn off*

Four connection box holding bolts torn out of motor body
