WEEKLY INCIDENT SUMMARY

Week ending Friday 14 August 2020

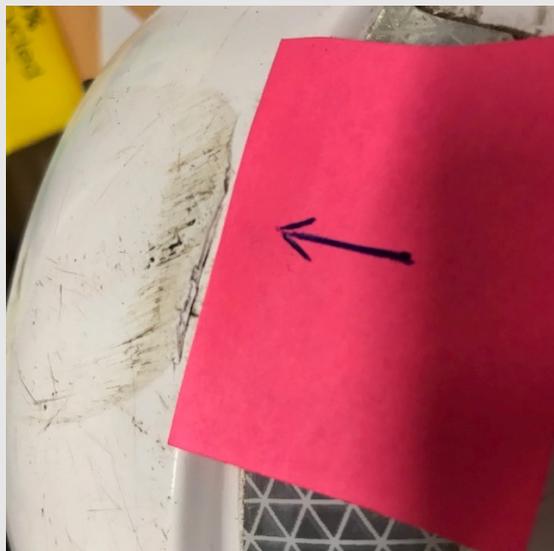
Dangerous incident
IncNot0037966
Open cut coal mine

A worker was hit on the back of the head by the access ladder of a grader that was being repaired. The force cracked his hard hat and knocked him to the ground. He suffered a concussion and whiplash. The ladder was stuck in the raised position due to insufficient oil in the control box. While the worker was waiting to top up the oil, the access ladder cycled down in an anticlockwise direction hitting him on the back of the head. The grader was not running at the time of the incident.

This incident is under investigation and further information may be published at a later date.

The hazards associated with moving parts of plant and machinery must be identified. Controls such as safe standing zones should be established in consideration of potential system failures.

No go zones must be identified and communicated to workers to ensure they remain out of the line of fire.

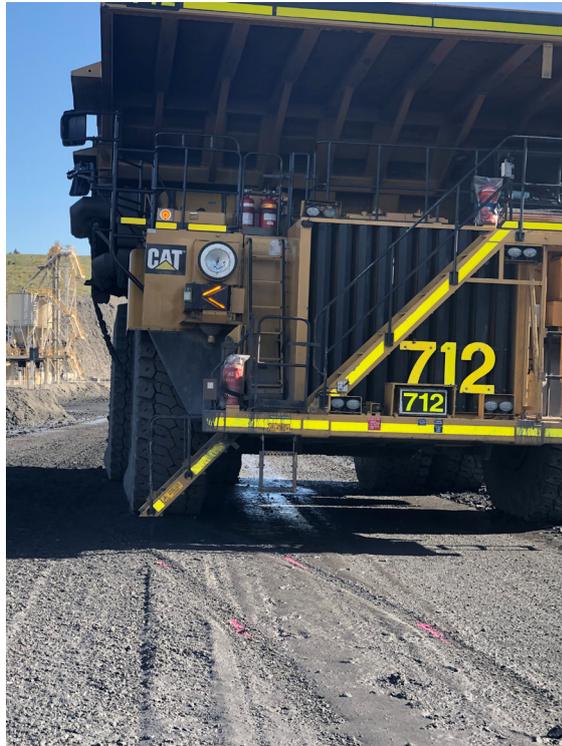
Dangerous incident
IncNot0037957
Open cut coal mine

A light vehicle turned in front of a haul truck at an intersection, narrowly avoiding a collision.

Video footage shows that the vehicle was extremely close to the front of the haul truck and the haul truck position 2 tyre ran over the light vehicle wheel tracks when attempting to stop.

The light vehicle driver said mud on the windows obstructed his view.

Vehicle operators should ensure they have clear visibility at all times by checking that windscreens. Windows and mirrors should be kept clean and free from obstructions.

If a driver is aware of reduced visibility due to mud on windows, the driver should find a safe place to stop and address the issue rather than risk causing an incident by continuing to drive with obstructed vision.
