## Walkway collapse puts workers at risk

This safety alert provides safety advice for the NSW mining industry.

CM9 reference	DOC18/937249
Mine safety reference	SA18-15
Date published	21 December 2018
Authorised by	Chief Inspector Office of the Chief Inspector

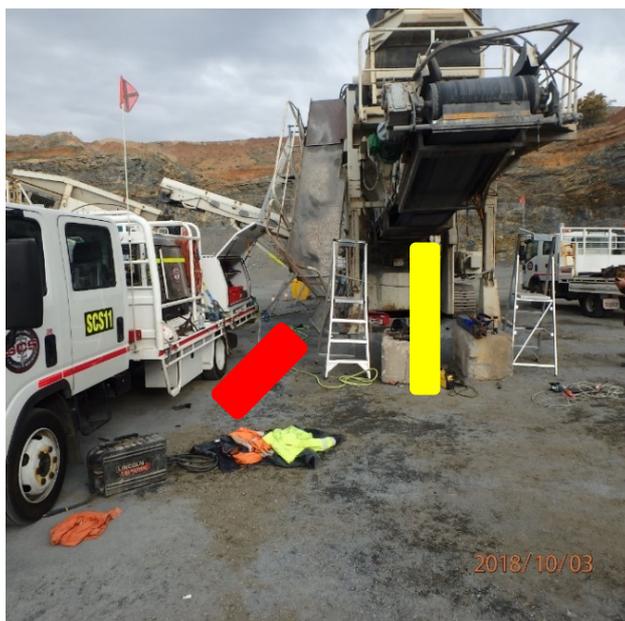
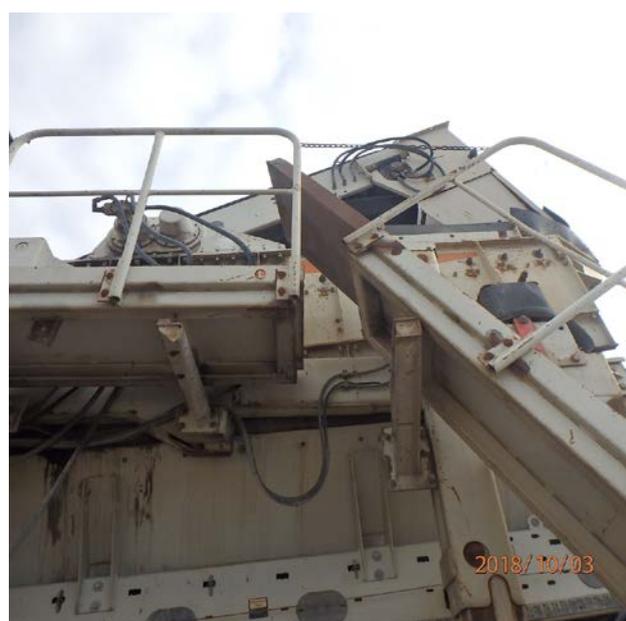
A contract leading hand supervisor (heavy plant fitter) fell about four metres to the ground when a platform walkway pivoted at a junction after supporting bolts were undone during maintenance at a quarry. There was an alteration to the maintenance task from the originally planned task.

The worker was on the end of the walkway and was ejected from the walkway when it collapsed. The worker suffered a dislocated right shoulder and fractures to his right shoulder. After hospitalisation, he had a brace fitted to his shoulder. Another worker at ground level was at high risk of injury from the collapsing walkway.

**Photographs 1 and 2: (Left to right) View of the collapsed walkway adjacent to the service truck. The injured worker (depicted in red) and the worker adjacent to walkway (depicted in yellow). (Right) View of the pivoted walkway. (Photographs by the Resources Regulator)**

- contractor management systems were not effectively monitored and evaluated for compliance by the mine operator during the maintenance task
- risk management did not identify additional hazards during the change management process from the original planned task. There was inadequate information provided to the contractor by the mine operator concerning the plant being maintained
- Environmental factors may have contributed: wet weather was imminent, and bolts were undone supporting the platform walkway in preparation for a crane arriving at the site to lift the platform walkway.

1. Contractor management systems to ensure adequate monitoring and evaluation of compliance for tasks undertaken by contractors.
2. The competency requirements of supervisors to ensure effective risk management of maintenance tasks and contractors undertaking the tasks.
3. Risk management processes to ensure effective identification of hazards and implementation of appropriate controls during change management for planned task assessments. Ensure that appropriate information is provided to contractors undertaking maintenance tasks on equipment.
