# WEEKLY INCIDENT SUMMARY

Week ending Friday 7 August 2020

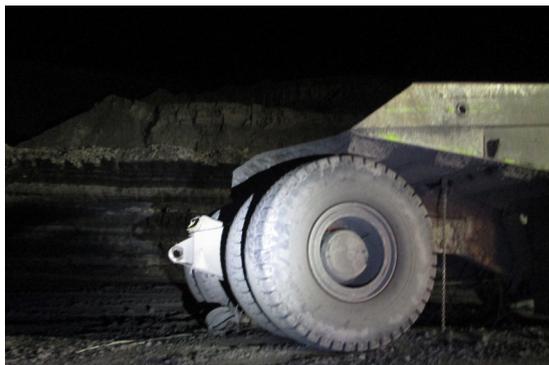
INCIDENT TYPE	SUMMARY	COMMENTS TO INDUSTRY
Dangerous incident IncNot0037912 Open cut coal mine	An empty haul truck was travelling around a corner when the rear axle box wheel assembly detached from the main truck frame. The retaining bolts for the trunnion pin failed, allowing the trunnion pin to dislodge.	This incident is under investigation and further information may be published later.  Following maintenance and repairs to mobile plant, the plant should be inspected, tested and verified as fit for purpose. Mobile plant should have suitable maintenance schedules that take into consideration condition and hours of operation.  Mine operators are reminded of the importance of following original equipment (OEM) maintenance schedules.

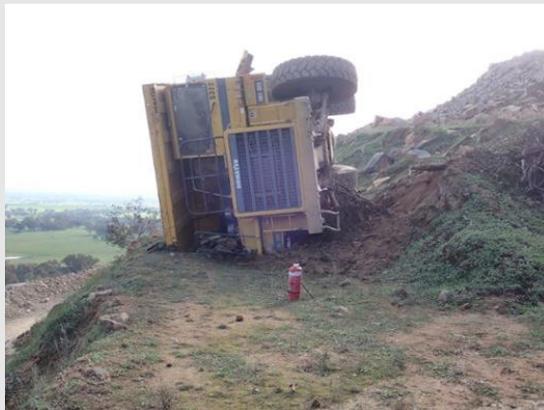
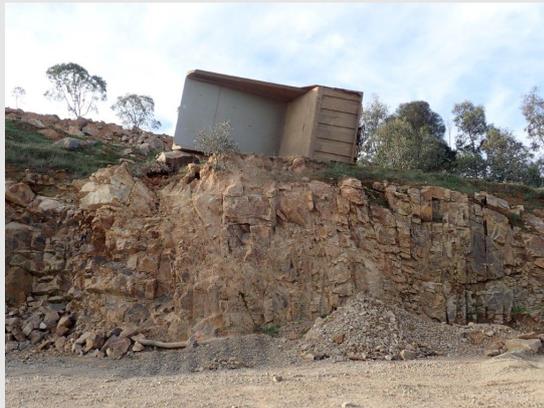
A rigid haul truck rolled over the side of a haul road, coming to rest on the edge of a steep drop.

The operator was wearing a seatbelt and suffered a minor injury.

Initial enquiries suggest that sunlight interfered with the driver's line of sight, causing him to drive into the bunding that was not adequate to hold up the truck. The truck drove over a large rock in the bund wall and tipped over.

Mine operators should ensure that bunds are designed, constructed and maintained to a standard that is suitable to protect workers from harm.

Principal hazard management plans for roads or other vehicle operating areas should consider factors that may affect operator visibility or ability to control a vehicle such as sunlight, fog, or dust obstructions that may affect lines of sight.

This incident also highlights the importance of wearing a seatbelt while operating mobile plant.
