SAFETY ALERT

Jumbo Trailing Cable Incident

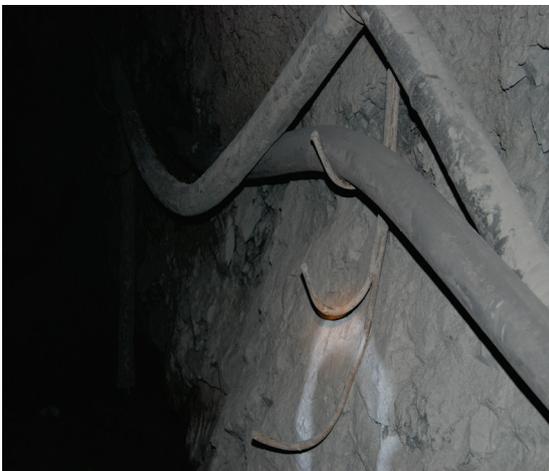
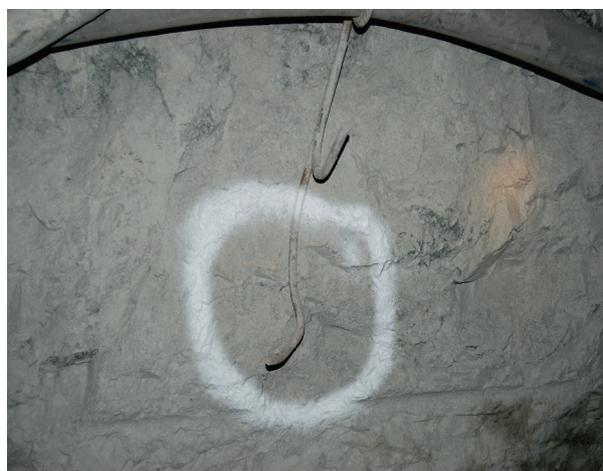
After the services were connected to the jumbo, the miner was walking back to the anchor point. As he walked back to the anchor point he lifted the trailing cable onto a quad hook hanger on the side wall. At the same time the jumbo operator commenced tramping the jumbo into the cuddy. It appears that as the jumbo commenced turning into the cuddy, which was perpendicular to the access drive, the trailing cable stopped reeling out from the cable reel. The trailing cable became highly tensioned between the anchor point and the back of the jumbo via the quad hook hanger. The quad hook deformed due to the excessive tension on it which resulted in the trailing cable slipping off the quad hook and whipping violently across the access drive. The miner was standing in the path of the trailing cable as it whipped across the drive. The trailing cable hit the miner on the left leg resulting in serious injuries.

Refer photographs of the deformed quad hook hanger and plan showing accident site below.

- establish and enforce no standing zones around mobile equipment and trailing cables when cables are being run in or out.
- reel out sufficient cable from the cable reel prior to tramming into areas that may result in the reeling out of a trailing cable stopping.
- consider the ability and effectiveness of installing a system in the operator's cabin that warns the operator when a trailing cable reel is stationary and cable stops running in or out.

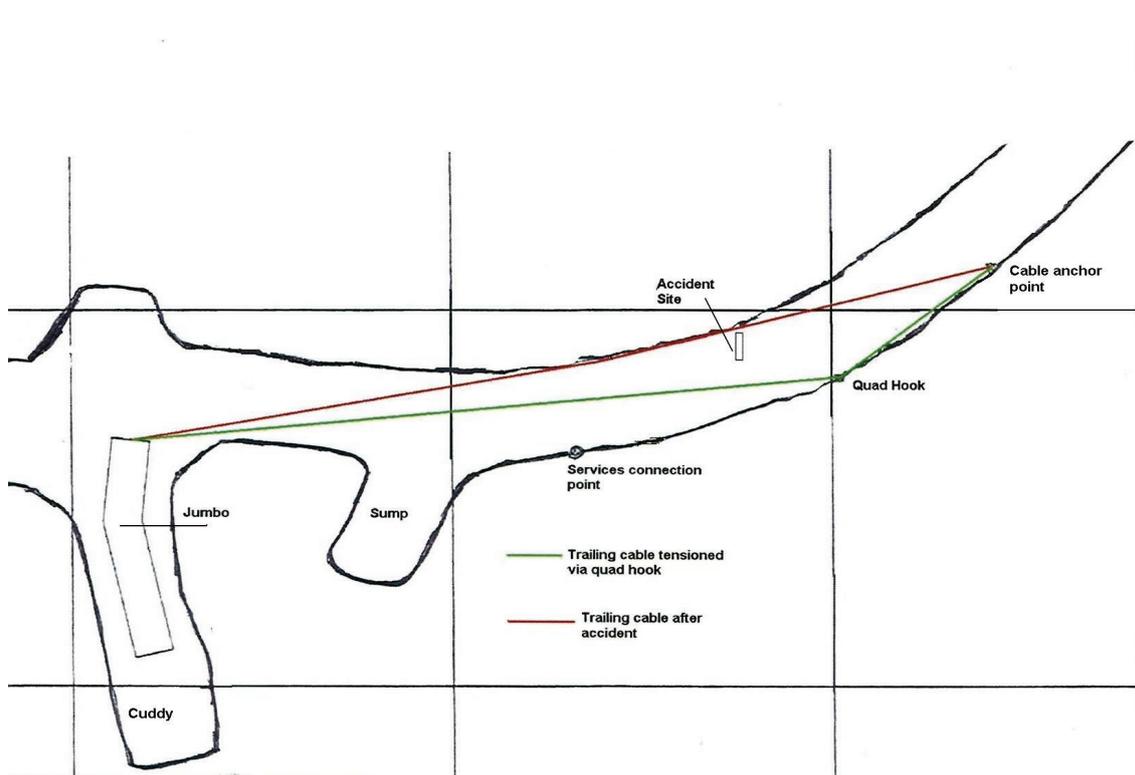
The miner was assisting a jumbo operator connect the cable and services to the jumbo prior to moving it into a cuddy to bore out a development face. The cuddy was approximately 55 metres from the trailing cable anchor point. The access drive to the cuddy was a 50 metre radius curve and the grade of the access drive varied from 1: 7 to 1:20 down.
