DATE: DECEMBER 2018

## Potential fall of excavator over highwall

This safety alert provides safety advice for the NSW mining industry.

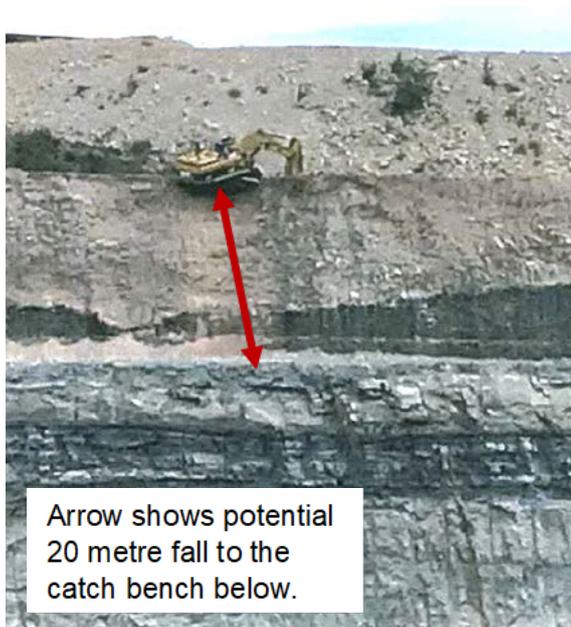
The activity was an alteration to a planned task and mine supervisors had not authorised the altered work method. The excavator reversed into an area where there was no highwall edge bunding. The excavator slumped over the edge when the edge collapsed. The operator got out of the cabin.

**Photograph 1: View of the excavator sitting on the edge of the highwall. (Photograph supplied by the mine)**

- documented tasks that are reviewed by supervisors should ensure that principal hazard risks are identified and adequately controlled (such as working near a highwall edge)
- adequate communication arrangements should be made with workers in service and maintenance crews so that when tasks are altered, and unplanned events occur, adequate notification for approval is made to a supervisor
- workers in service and maintenance crews should be considered in the supervisory arrangements for the relevant statutory supervisor
- review highwall edge bunding to design specifications in work areas to prevent mining equipment going over highwall edges and have adequate demarcation in areas where appropriate bunding is not installed
- review that the equipment used for handling poly pipe is fit-for-purpose.

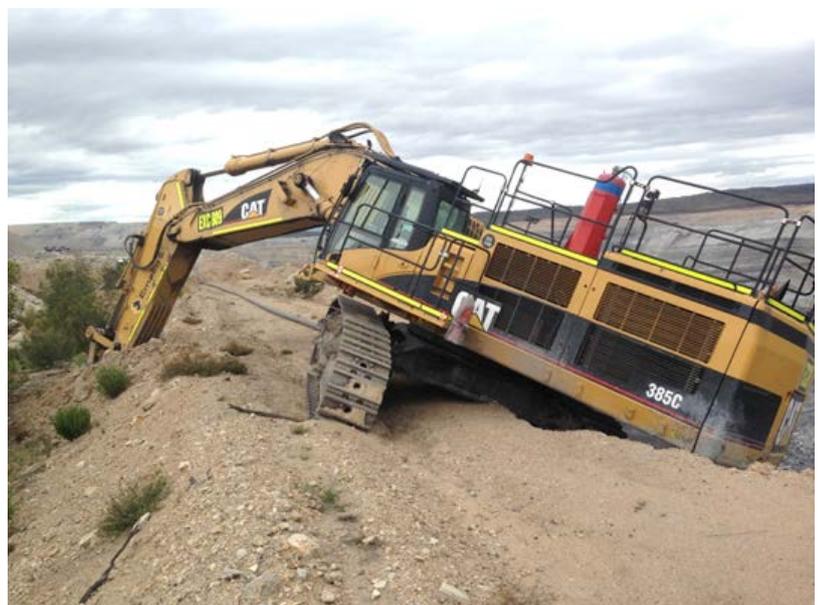
The services crew leading hand then disconnected the poly pipe from the excavator, got into the cabin, and rotated the excavator to secure the bucket into the ground. Rotating the excavator significantly increased the potential risk of the machine falling over the highwall.

**Photograph 2: View from the bench of the excavator rotated over the edge of the highwall. (Photograph by Resources Regulator)**
