# SAFETY ALERT

## Light vehicle drives off bench in open cut mine

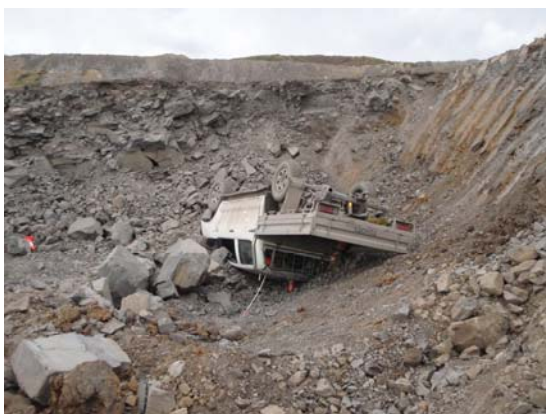
While exiting the bench he drove over a 4.5 metre low wall and the vehicle landed on its roof. The operator had been on the bench for approximately one minute.

**The light vehicle at rest after being driven off the bench (left); and a view at the top of the bench from which the vehicle fell (right).**

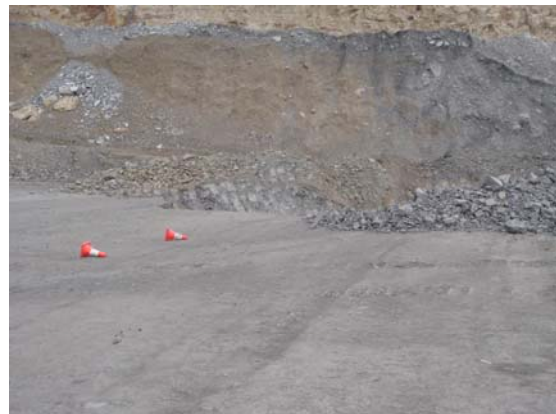
The operator confused a small amount of material on the bench for the windrow of the ramp. The ramp windrow finished at the same point as the edge of the top of the low wall.

The top of the ramp was not clearly delineated. The edge of the low wall was not delineated. There was no barrier to warn the operator he was approaching the edge of the ramp.

1. All personnel should notify the relevant mining official when they are entering a work area.
2. All operators should receive positive communication from the mining supervisor and any machinery operator in the work area they are entering.
3. Operators should be familiar with their work environment before working in the area.
4. An inspection should be undertaken to ensure that surface transport management plan requirements are in place. The surface transport management plan should be reviewed and, if found deficient, should be strengthened.
5. All operators should wear seat belts while operating machinery.
