WEEKLY INCIDENT SUMMARY

Week ending Friday 25 September 2020

Dangerous incident
IncNot0038309
Underground coal mine

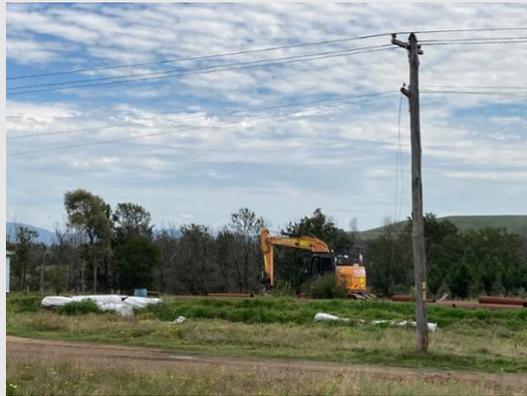
A 14-tonne excavator contacted 415v overhead power lines whilst tramming over uneven ground. When the excavator bucket contacted the ground, the operator lifted the boom and continued tramming. The excavator body rocked, and the boom contacted the power lines, pulling two conductors to the ground. The excavator operator was uninjured.

If work on a mine site involves daily movement of machinery with the ability to reach powerlines, consideration should be given to the relocation of the lines or determining alternate routes to eliminate the risk of electric shock.
