Elevated workbox falls from a loader

This safety alert provides safety advice for the NSW mining industry.

CM9 reference	DOC19/12244
Mine safety reference	SA19-01
Date published	15 January 2019
Authorised by	Chief Inspector Office of the Chief Inspector, NSW Resource Regulator

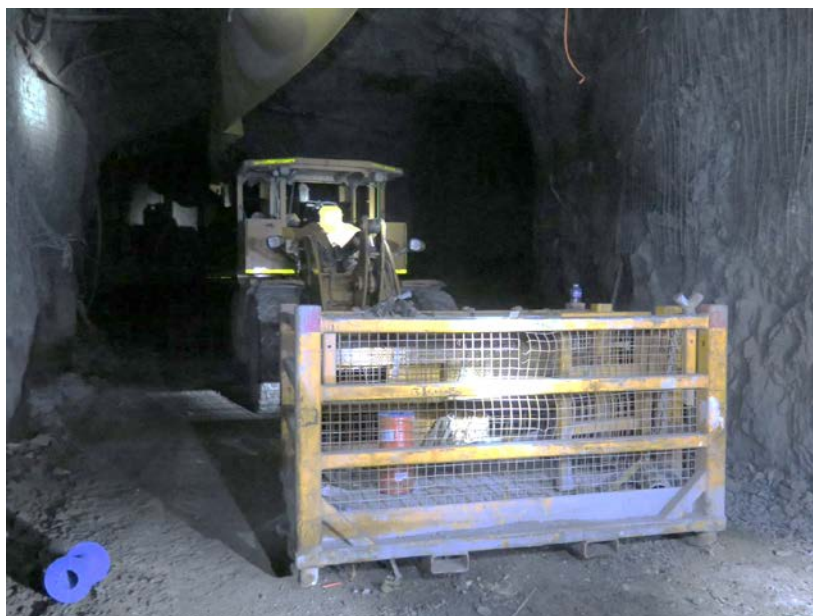
The loader operator selected the workbox locking pin release switch. The locking pin disengaged causing the workbox to detach from the loader and fall to the ground.

Figure 1. View of the loader and the workbox on the ground. (Photograph by the Resources Regulator)

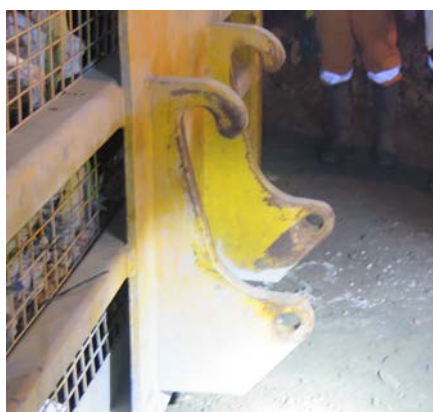
The workbox attachment assembly was not fully compatible with the attachment assembly on the loader. When the locking pins were disengaged, the attachment was able to swing, disengaging from the attachment hook.

Figure 2. The workbox attachment hitch (Photograph by Resources Regulator)

- workbox attachment systems are fit-for-purpose with machine attachment systems
- change management arrangements for the modification and maintenance of workbox attachment systems are to be assessed in consultation with relevant equipment manufacturers or engineering specialists
- for any modified plant, mines should conduct thorough assessments to ensure compatibility with existing site equipment and attachments
- operational switches in mobile equipment are of an appropriate type, positioned and labelled appropriately to prevent inadvertent operation and consider additional barriers or protection of the locking pin release switch
- information, instruction and training is provided to, and implemented by workers for the safe use of workboxes.

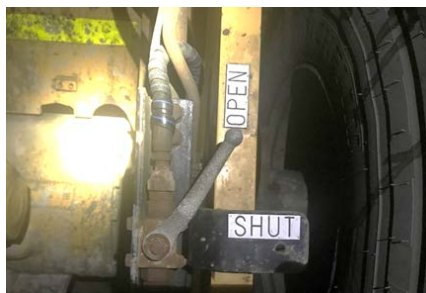
The hydraulic isolation valve was not engaged to stop the locking pin (that was holding the workbox) from disengaging during operation.

- The locking pin was not hydraulically isolated in line with operational procedures and the pre-start checklist.

Figure 4. Hydraulic isolation valve handle in the open position. (Photograph by Resources Regulator)

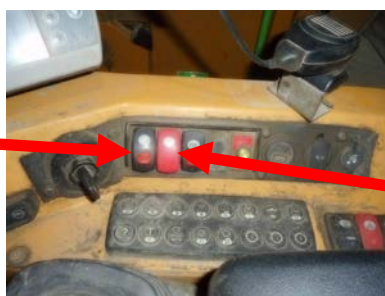
- The switch panel layout presented a risk of incorrect switch selection.

Figure 5. View of the switch panel layout inside the cabin of the incident loader. (Photograph by Resources Regulator)

Locking pin release switch

Park brake switch
