SAFETY ALERT

HOT WATER FROM PUMP BURNS QUARRY WORKER

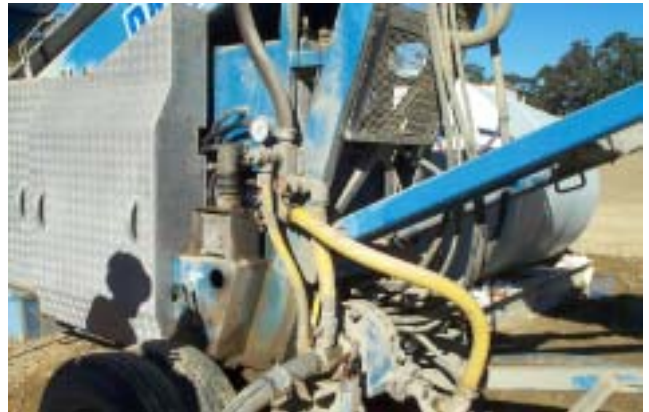
The water spray circuit has a pressure relief valve and a manually operated flow control valve that returns all water to the suction side of the pump.

With the control valve closed, the design of the circuit caused the water to keep recirculating through the pump. This generated enough heat and pressure to eventually blow the delivery hose off.

Photo above shows operator's station, water spray pump and hydraulic lines.

The design of these types of circuits must follow safe engineering practice:

1. The relief valve return line routed back to tank.
2. The manual flow control valve return line routed back to tank.
3. All pipes, hoses and connections fit for purpose with a minimum factor of safety of 4 to 1 burst pressure to maximum working pressure as per Australian Standards.
