INVESTIGATION INFORMATION RELEASE

AUGUST 2019

Improving progressive rehabilitation at Whitehaven's open cut coal mines

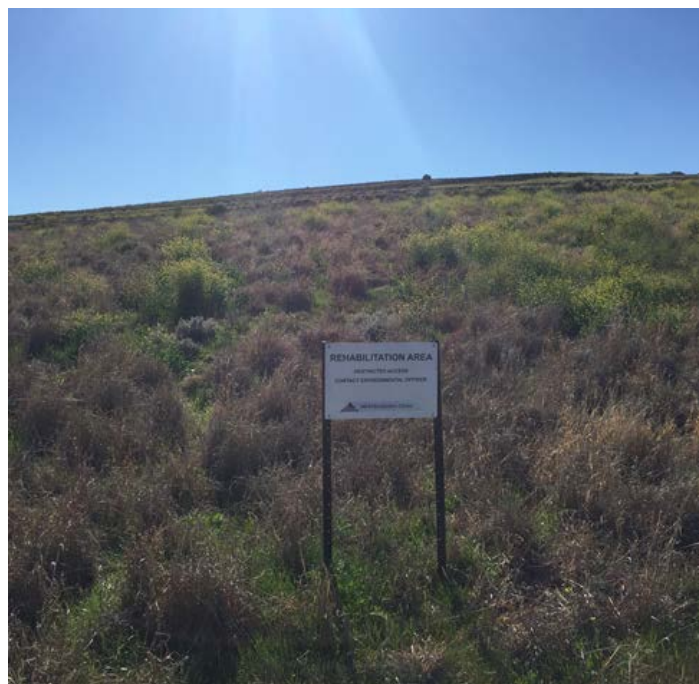
Figure 1 Tarrawonga Coal Mine's poorly wooded revegetation

Figure 1 shows poor revegetation at Tarrawonga. This area was shaped five to six years ago, with an open woodland rehabilitation objective.

This photograph shows no visible signs of established tree species. Rather, the rehabilitation area has a thick cover of exotic grasses and weed species. Under these circumstances, establishing a woodland area would be difficult and resource intensive.

The Regulator has issued statutory notices pursuant to section 240(1)(c) of the *Mining Act 1992* to Whitehaven Coal Mining Ltd requiring it to engage suitably qualified experts across its four operations (Tarrawonga, Rocglen, Sunnyside and Maules Creek) to:

- provide information regarding the status of progressive rehabilitation
- advise whether progressive rehabilitation has been undertaken in accordance with approved plans and strategies
- identify measures or actions to improve progressive rehabilitation performance

- submit a report to the Regulator that includes a timeline to improve progressive rehabilitation at each site.

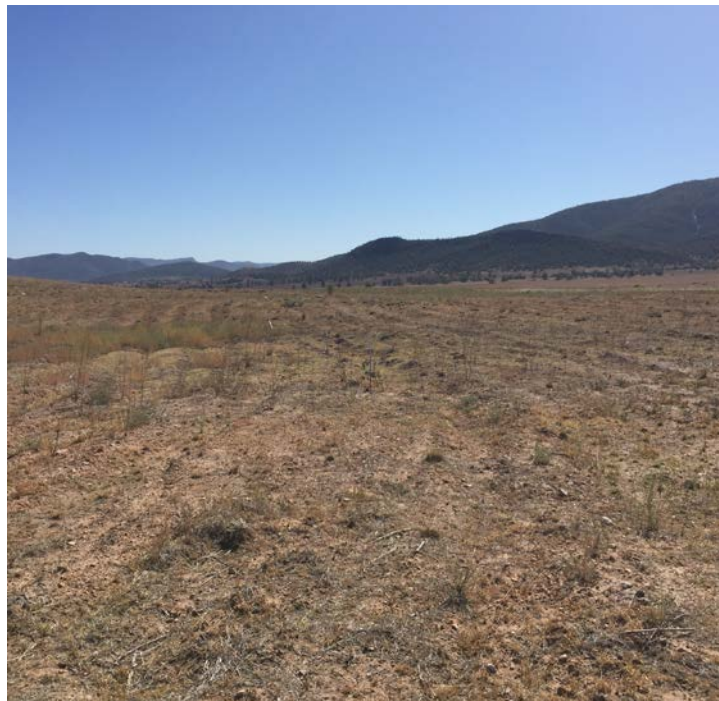
Figure 2 Woodland revegetation at Rocglen Mine

Figure 2 depicts the third attempt of woodland revegetation at the Rocglen Mine Northern Emplacement Area. Its target rehabilitation objective was open woodland. This area is three to five years old and is **not progressing well**. Tubestock has been planted in this area on three occasions without success.
